Influence of Environment Corrosion on the Fatigue Performance of Expressway Bridges

Keywords: Environment corrosion; Reinforcement corrosion; Pre-stressed concrete beam; Fatigue performance

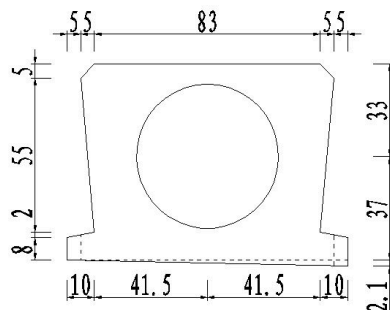
Fig. 1. 16 m hollow beam cross-sectional dimensions

reduced-scale model. The actual sectional dimensions of the hollow slab beam are shown in Fig. 1.

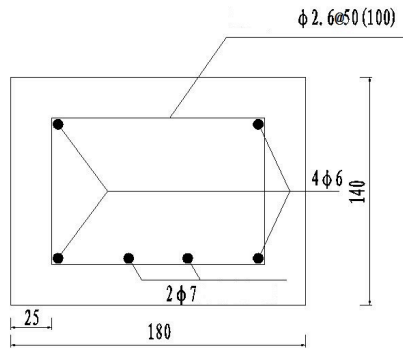
Fig. 2. Model beam section reinforcement figure

reinforcement was a pre-stressed wire. The tensile stress was 0.73 times that of the standard tensile strength value, and the maximum tension value did not exceed 1.05 times. The ordinary reinforcement was HPB300 reinforcement with a diameter of 6 mm. The stirrups were 12# iron wires with a diameter of 2.6 mm interspaced at 100 mm; the interspacing was narrowed to 50 mm near the support. The measured values of material strength are listed in Tables 1 and 2, and the arrangement of the reinforcement of the model beam section is shown in Fig. 2.

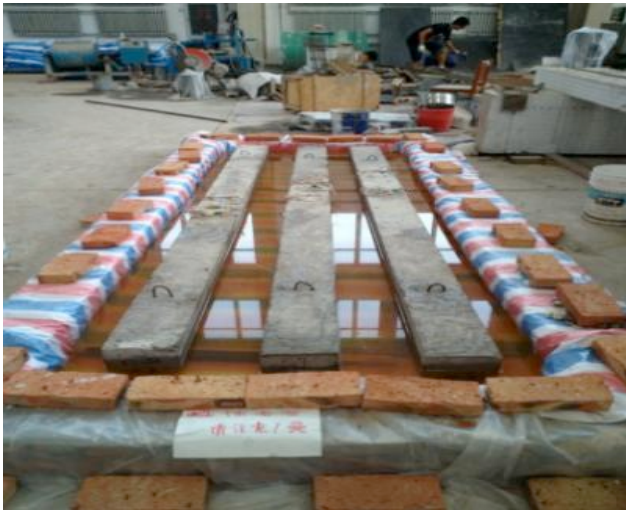
Fig. 3. Corrosion test

The accelerated corrosion method with discontinuous power switching was selected. Before switching the power on, the beam was half dipped in a 5% solution for 24 h, and the stressed reinforcement wire was connected to the anode of a constant DC power source. A stainless steel plate in sodium chloride solution was connected to its cathode, and the solution was used for the reinforcement to gradually form a corrosion loop. The DC power source was kept constant during the process. Corrosion current was 1 mA/cm^2 , and test beams of different corrosion rates were obtained by controlling two indexes (i.e., time and current density). Faraday's law states that the working current intensity and conduction time required for a test beam to reach a designed corrosion rate can be roughly calculated. The corrosion parameters are listed in Table 3. Fig. 3 shows the corrosion test, and Fig. 4 shows the DC power source utilized in the test.

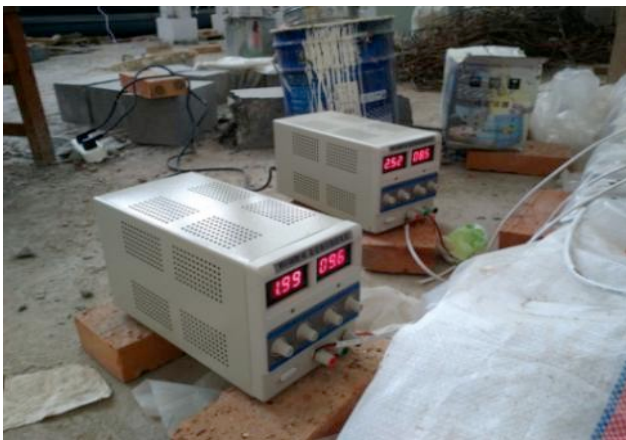
Fig. 4. DC electrical source of the corrosion test

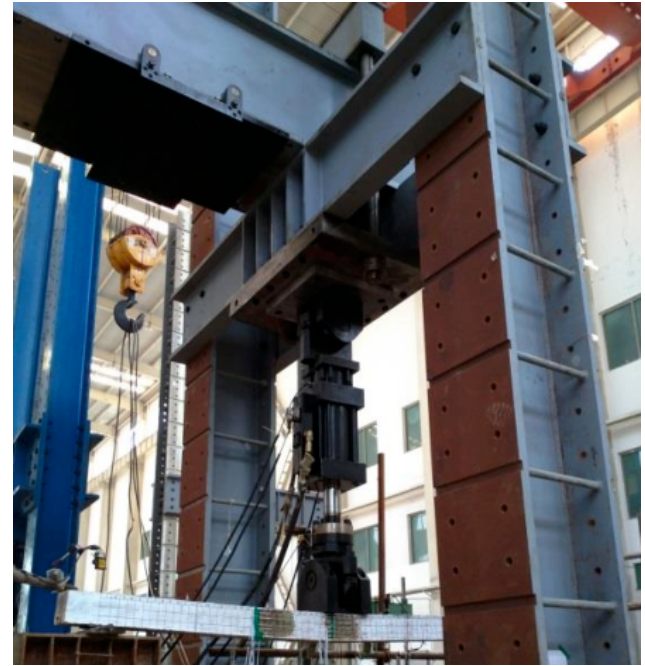
Fig. 5. Fatigue test

Three test beams with different corrosion rates were included in the test. An MTS electro-hydraulic servo fatigue testing machine with a loading frequency of 3.5 Hz was used. The test is shown in Fig. 5. The upper and lower limit values of the applied load were obtained according to Table 4, and the test results are listed in Table 5.

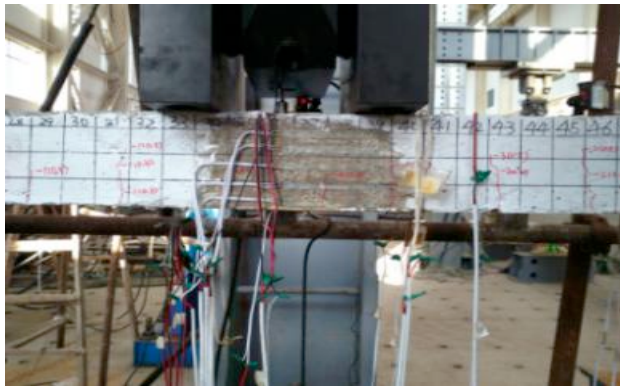
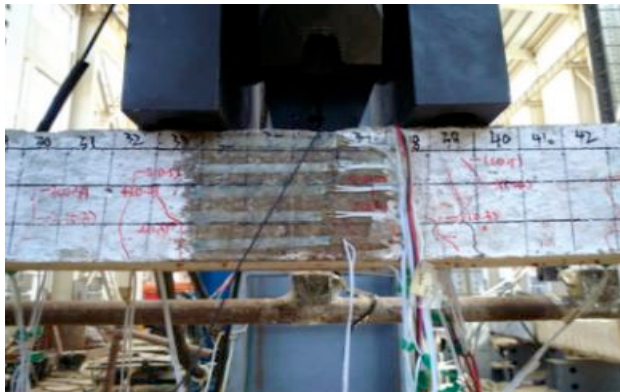
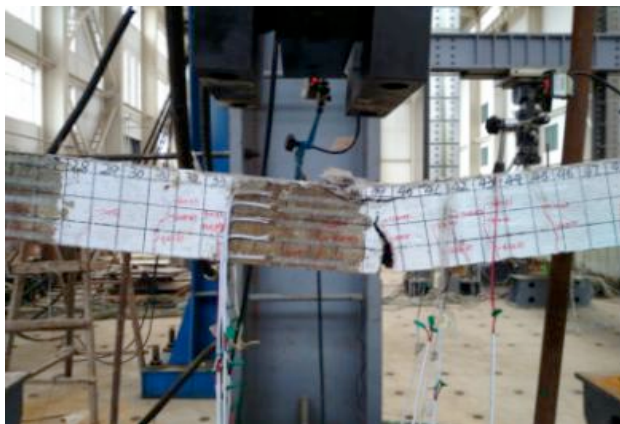
Fig. 6. PL4 to PL6 failure patterns under fatigue load

Test beams PL5 and PL6 suffered fatigue brittle failure in the form of reinforcement cracking (Fig. 6). Compared with the failure mode of non-corroded test beam PL4, the local part of the corroded test beams suffered bond failure caused by longitudinal cracks generated after the test beams suffered corrosion. The number of cracks that developed on

beam PL4 was small, and the cracks were distributed sparsely. Many dense cracks were generated on corroded test beam PL5. The number of cracks on corroded test beam PL6 was second to that on PL5. PL6 also suffered brittle failure along the major crack without a clear sign. When the load level was fixed, the increase in the corrosion rate resulted in a sudden shortening of the fatigue life of the test beams. The fatigue life of the test beams with corrosion rates of 5% and

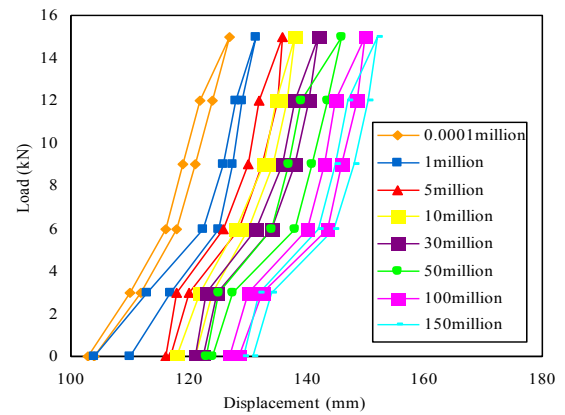
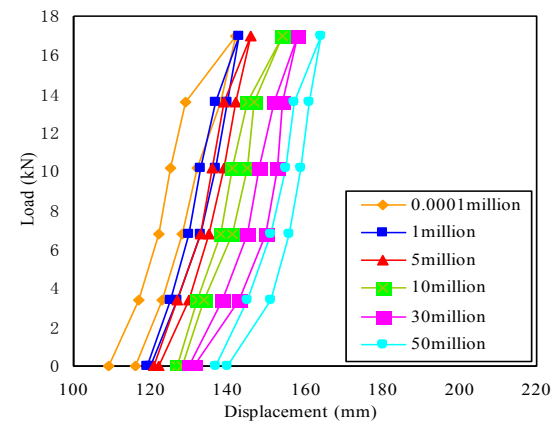
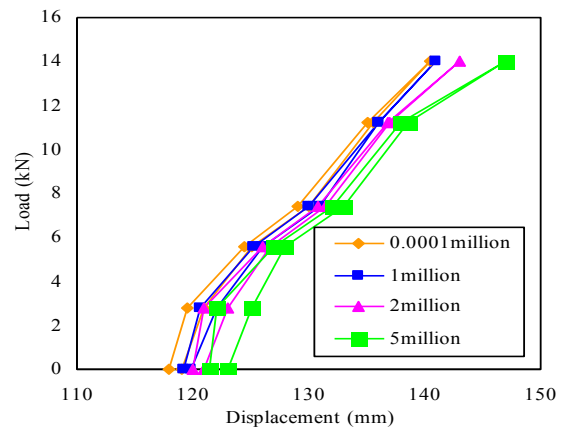
Fig. 7. PL4 to PL6 failure patterns under fatigue load

The overall curve change in Fig. 7 shows that with the progressive increase in fatigue repetition times, the slope of the load–displacement curve of non-corroded test beam PL4 was basically unchanged. By contrast, those of corroded test beams PL5 and PL6 continuously decreased, and the higher the corrosion rate was, the more obvious the slope decreased. Beam displacement under unloading increased, unlike that of the beam under loading for each load stage. This scenario indicates that during the increase in the cycle index of the load, an equal cycle index of fatigue load increased the failure degrees of the beams. Plastic deformation also gradually occurred on the test beams.

the initial test phase. The overall process basically presented a linear growth. Plastic deformation gradually increased with the progressive increase in the load repetition times, and plastic deformation was mainly generated from the initial test phase before beam failure. The increment in the plastic deformation of beam PL5 was much larger than that of PL4, which indicates that the test beam entered the yield phase in advance after reinforcement corrosion. This condition is due to factors, such as corrosion pits and corrosion–expansion cracks of the reinforcement. The slope of the load–displacement curve for test beam PL6 decreased, and the increase in plastic deformation mainly occurred before the failure of the test beam. All of these results prove that an increase in the corrosion rate can cause brittle rupture of pre-stressed concrete beams.

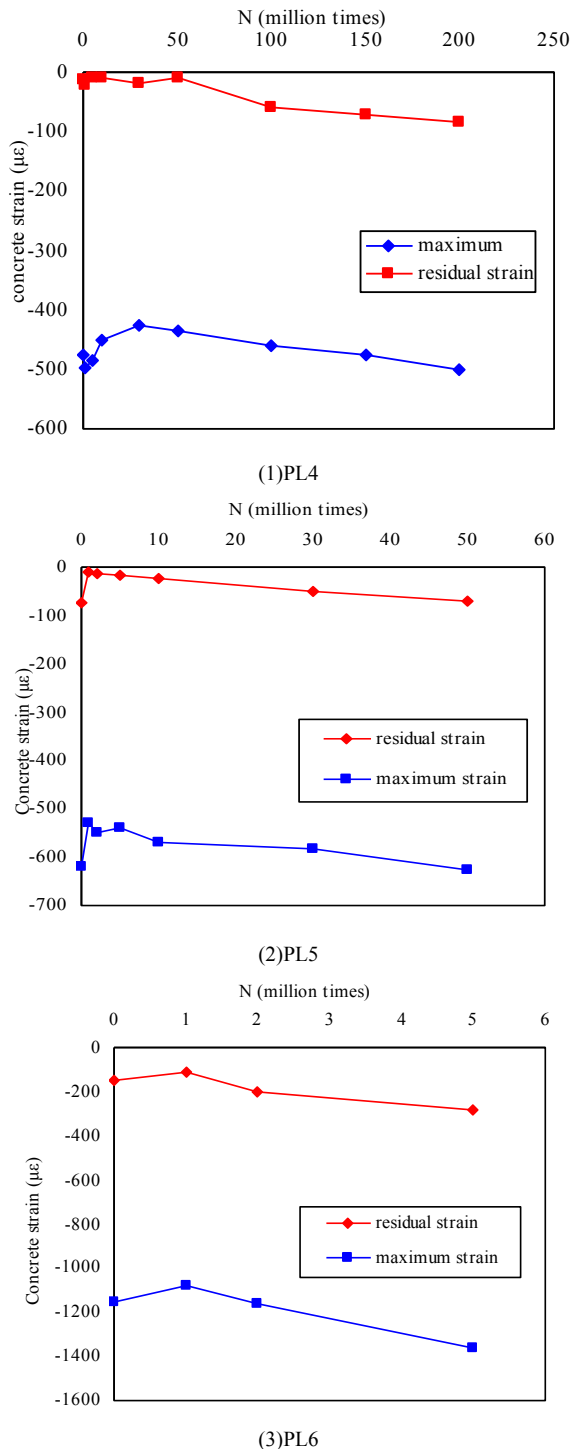
Fig. 8. Concrete strain-fatigue number curves of beams PL4 to PL6

The maximum and residual strain curves of all the test beams presented “three-phase” characteristics, namely, slow, stable, and rapid growth phases of concrete strain. A comparison of test beams PL4 and PL5 showed that the maximum concrete strain of the lightly corroded test beam was slightly larger than that of the non-corroded test beam, but the residual strains of the two were basically identical. A comparison of test beams PL5 and PL6 showed that the maximum strain of concrete in the compressive zone suddenly increased with the progressive increase in the reinforcement corrosion rate. The residual concrete strain of beam PL6 after failure was approximately twice that of PL5 after fatigue failure.

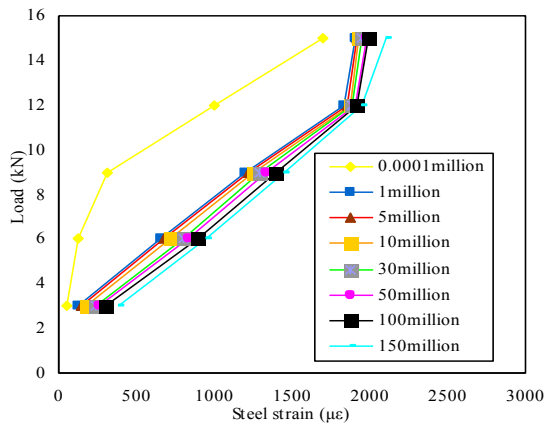
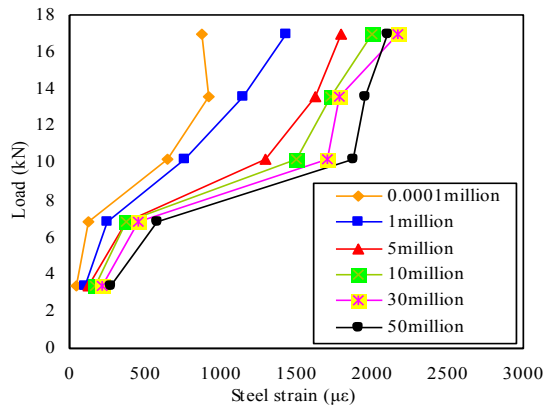
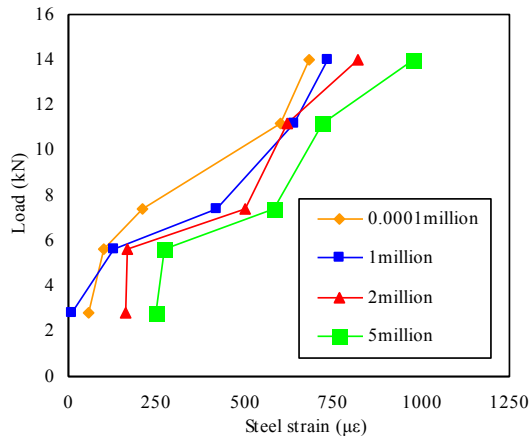
Fig. 10. Reinforcement load-strain curve of beams PL4 to PL6

Fig. 10 shows that the strain of ordinary reinforcement gradually increased with the progressive increase in the loading repetition times. The strain of the ordinary reinforcement of test beam PL4 presented a linear growth, and its curves remained parallel. The fatigue load stress was relatively low, and when the reinforcement was not corroded,

the reinforcement of the test beam was basically in the elastic phase. Figs. 5.13 and 5.14 show that the strain change rules of the ordinary reinforcement of corroded test beams PL5 and PL6 can be roughly divided into three phases: elastic development, sudden increase, and stable development. The strain distributions of the ordinary reinforcement of test beams PL5 and PL6 were relatively dispersed and mainly presented linear growth in the initial loading phase (within 10,000 times). As the loading repetition times increased progressively, the strain of ordinary reinforcement abruptly increased, and the reinforcement underwent plastic deformation. Comparison shows that the stable development phase of test beam PL6 with a high corrosion rate before failure was not obvious, unlike that of test beam PL5 with a low corrosion rate.

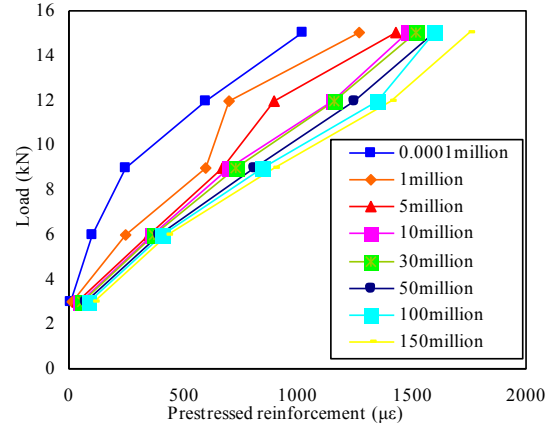
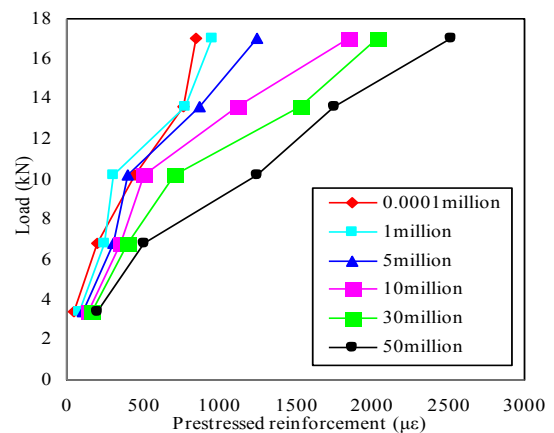
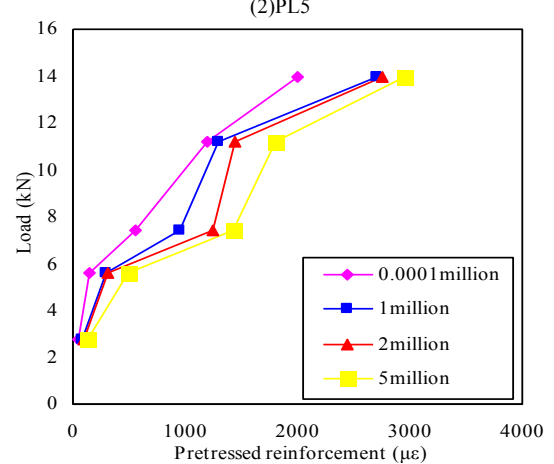
Fig. 11. Pre-stressed load-strain curve of beams PL4 to PL6

Fig. 11 shows that under the effect of cyclic load, the strain development trend of pre-stressed reinforcement was similar to that of ordinary reinforcement. The pre-stressed reinforcement strain correspondingly increased because of the progressive increase in the fatigue repetition times. Different from those of ordinary reinforcement, the pre-stressed reinforcement strains of beams PL4 to PL6 presented linear growth in the early loading phase. As the corrosion rate increased, the strain of the pre-stressed reinforcement after an equal cycle index of fatigue became larger than that of the beams under the fatigue test. For example, the pre-stressed strains of test beam PL6 after 50,000 times of fatigue repetition were about 2.5 times that of test beam PL5. Strain of test beam PL6 under failure was about 1.1 and 1.8 times those of beams PL5 and PL4, respectively.
