Experimental Study on Flexural Capacity of Reinforced Concrete Beam after Collision

Keywords: Bridge engineering, Vehicle–bridge collision, Damaged beam, Flexural capacity, Loading test

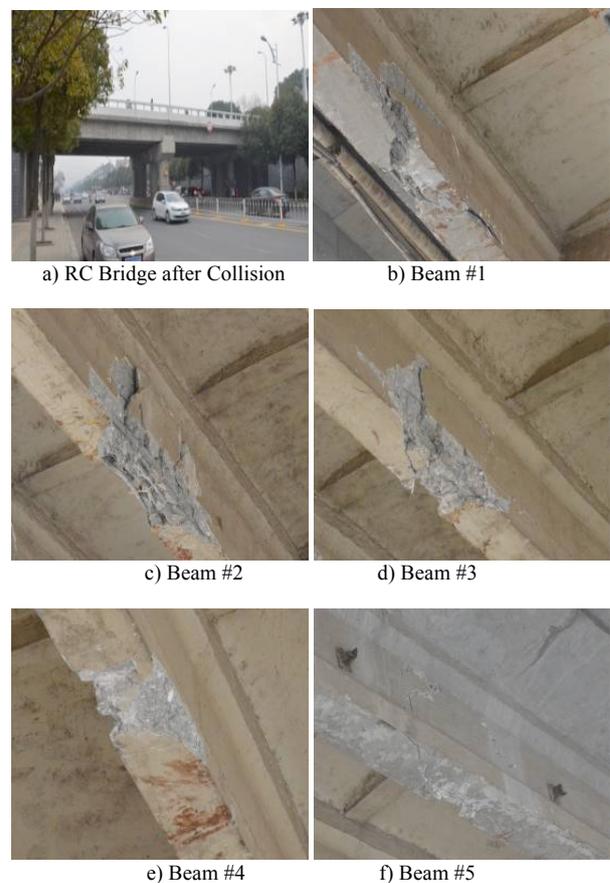
Fig. 1. RC Bridge and Beams after Collision

Fig.1 shows that with five beams damaged, beam #2 sustained the most serious damage, followed by beam #3. The protective layer of beam #4 was cracked. Therefore, considering bridge demolition safety, beam #3 and #4 were demolished and transported to the lab for an experiment. Grids with 10-cm spaces were drawn with ink lines on the surfaces at two sides of the beams (Fig. 2) to measure the damage of the beam accurately and observe the cracks during the follow-up loading test. The state of damaged beam #3 section is shown in Fig. 3.

A two-hole 13-m RC I-beam flyover in Yueyang, Hunan Province was built in 1995 with a designed load of vehicle-15. The bridge superstructure is five I-beams. In December 2014, a truck carrying an excavator (the total weight of which was about 20 t) passed under the bridge. The long arm of the excavator was not placed as it should be required, When the truck passed below the bridge, the long arm of the excavator collided with the bottom of the main bridge beam. Several main beams were seriously damaged, as shown in Fig. 1.

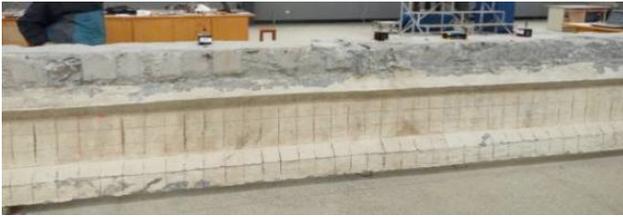
Fig. 2. Grid Lines for Observation of Main Beam Cracks

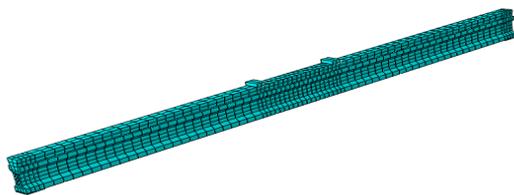
The measuring results from the previous stage were used to establish finite element analysis models (Figs. 6 and 7). The models showed that concrete adopting an elastic-plastic-damage constitutive model had a good bonding with the rebar, for which an elastic-plastic constitutive model was adopted, and the conquassation of concrete in the compressive zone was taken as a criterion for model damage, as shown in Fig. 8. Concrete was simulated with a solid element and rebar was simulated with a bar element.

Fig. 6. Finite Element Model of Undamaged Beam

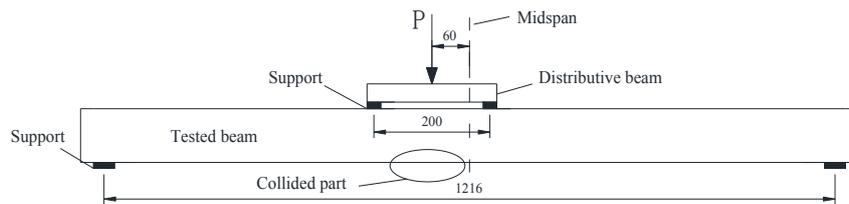
Specific loading measures are shown in Fig. 9. A distributive beam was set below an actuator, and supports (one fixed support and one movable support) were set symmetrically at the two ends of the distributive beam. During loading, the actuator implemented single-point loading, and the load was transferred to the main beam

Fig. 9. Loading Diagram (Unit: cm)

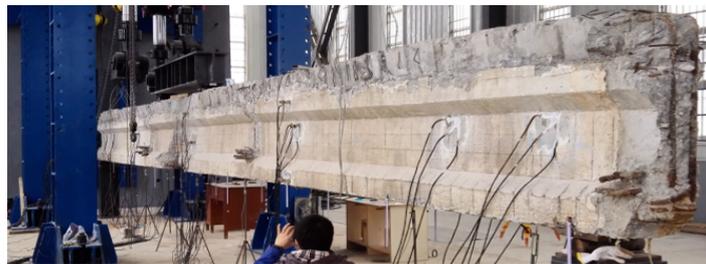
Fig. 11. Strain Measuring Point Arrangement of Damaged Beam

2) The strain was measured with two sets of systems, the strain gauge and the vibrating wire strainmeter, which were simultaneously used in the test and implemented mutual calibration. The bridge has been used for years. Thus, strain rosettes were set in positions which were 10 cm away from the support and equivalent to the beam height and 1/4 of the section, to prevent the recessive damage of some unknown parts from the changing failure mode of the structure. Strain measuring points in the axial direction of the beam were set in positions, namely, the midspan section, the collision section, and the load-bearing rebar, as shown in Figs. 11 and 12.

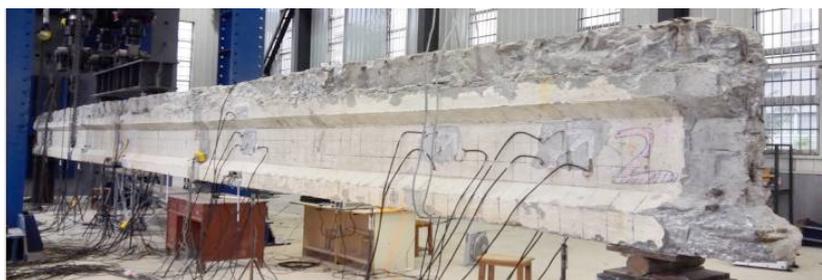
Fig. 12. Strain Measuring Point Arrangement of Undamaged Beam

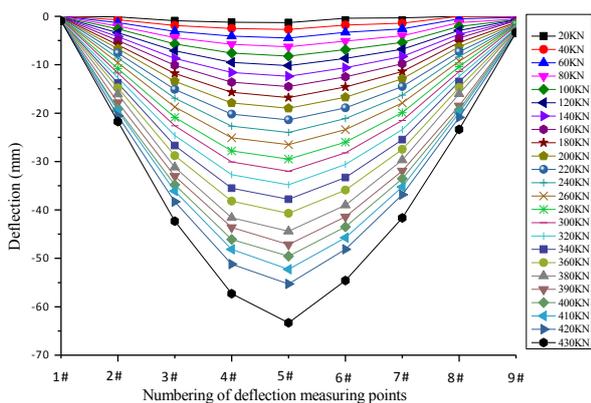
Fig. 13. Deflection of Damaged Beam under Effect of Multi-Stage Load

Fig. 13 shows that the deflection of measuring point 4# (3L/8 section) near the collision position of the main beam was larger than that of measuring point 6# (5L/8 section), which indicated that the damage affected the local beam deflection. After 360 kN was loaded, the changing rate of deflection increased, which indicated that the main beam rigidity rapidly decreased and entered the plastic state. The

ultimate load of the damaged beam was approximately 430 kN , and the maximum deflection of the midspan deflection position was approximately 65 mm .

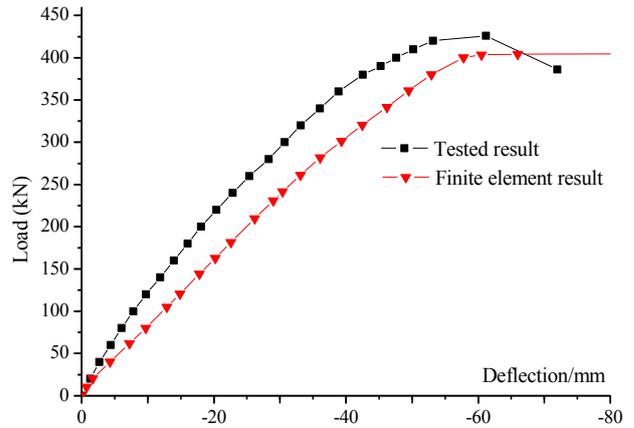
Fig. 14. Comparison Chart of Load-Deflection Curves of Damaged Beam

The comparison between the load-deflection test curves and the finite element analysis result of the midspan section is shown in Fig. 14. The theoretical deformation value of the damaged beam was greater than the measured value in the test when loading was implemented. Thus, the rigidity of the finite element model was smaller than the actual rigidity of the tested beam. The difference between the theoretical and measured values reached the maximum at 360 kN . One rebar at the beam bottom yielded with the increasing growth rate of the test value, which exceeded that of the analytical value. The tested deformation was approximate to the calculated deformation after the concrete in the compressive zone was crushed. Moreover, no obvious linear segment appeared in the initial loading stage on the load-deflection curve of the damaged beam. Thus, no elastic phase appeared in the initial loading phase of the RC beam because of the damage.

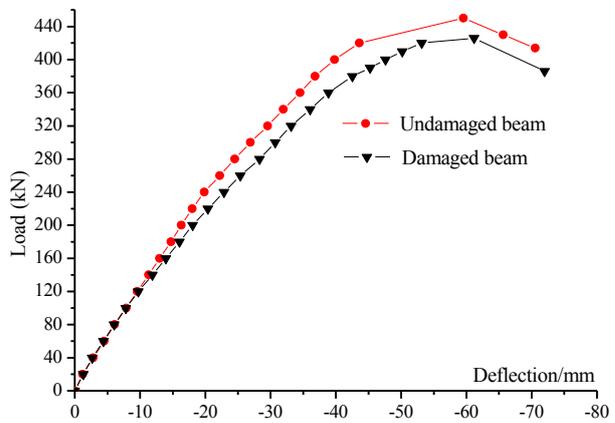
Fig. 15. Comparative Curves of Measured Load-Deflection Values of Midspan Section

A comparison between the damaged and undamaged beams through the load-deflection test curves of the midspan section is shown in Fig. 15. During the loading process, the deformation of the damaged beam under the same load was greater than the deformation of the undamaged beam because the beam damage reduced its rigidity. However, for the ultimate load, the deflection of the damaged beam was basically identical with that of the

undamaged beam. The ultimate load of the damaged beam was 430 kN, and that of the undamaged beam was 440 kN. Thus, the ultimate load of the undamaged beam was slightly higher than that of the damaged beam by 2.3%, which indicated that the concrete damage in the tensile zone in the midspan region had minimal influence on the bearing capacity, thus verifying that concrete strength might not be considered in the concrete structural calculation. Moreover, in the initial loading phase, an obvious linear segment on the load–deflection curves of the undamaged beam existed but not on the load–deflection curves of the damaged beam.

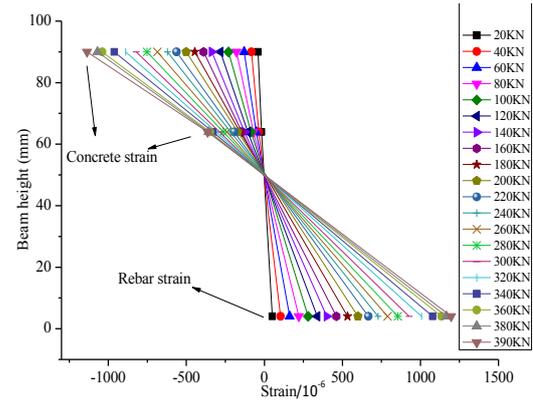
Fig. 19. Concrete and Rebar Strains of the Midspan Section

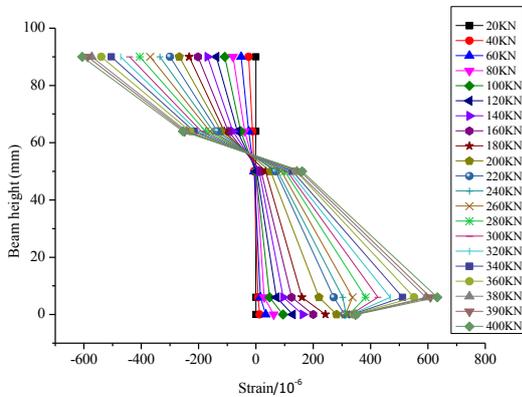
Figs. 16 and 18 show that the strain distributions at the 1/4 and 3/4 sections of the damaged beam along the beam depth were basically consistent with the plane-section assumption, but the maximum tensile strains of the two sections were not at the beam bottom because the concrete on the lower section in the midspan region loosened after the collision and stress redistribution occurred at the beam bottom, which reduced the stress of concrete on the lower 1/4 and 3/4 sections to a certain degree. Fig. 17 shows that the lower strain on the midspan section was small and the concrete strain in the tensile zone did not conform to the plane-section assumption because of the influence of concrete loosening and “rounding” cracks at the edges of the damaged section. This part of concrete mainly exited from the operation. Fig. 19 indicated that the concrete strain in the compressive zone of the midspan section and the rebar strain in the tensile zone were consistent with the plane-section assumption.

Fig. 16. Concrete Strain Value of the 1/4 Section

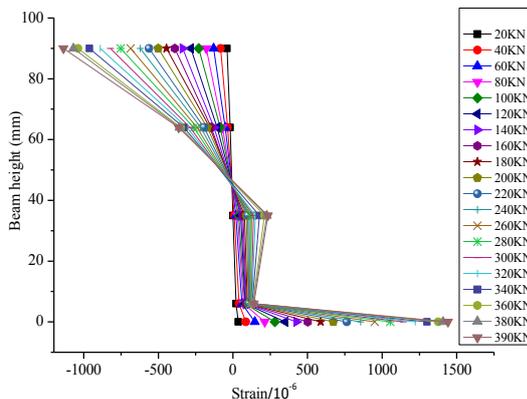
Fig. 17. Concrete Strain of the Midspan Section

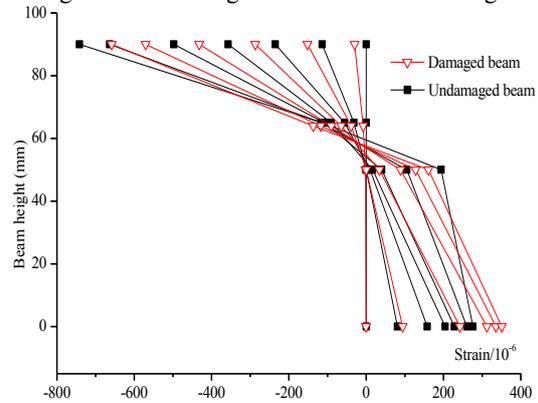
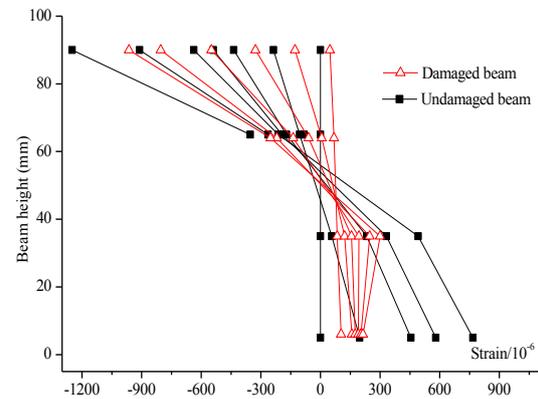
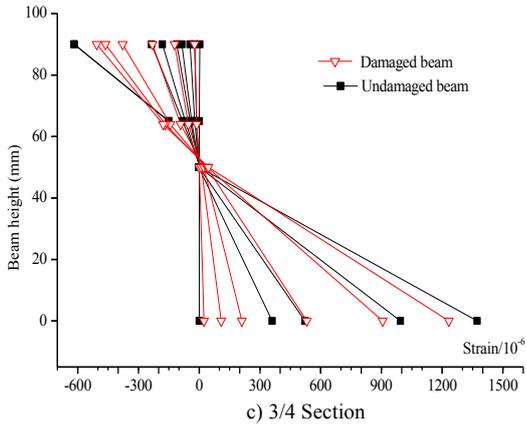
The comparison of the concrete strain curves of the damaged and undamaged beams is shown in Fig. 20.

Fig. 20. Comparison Diagram of Concrete Strain of Various Sections

Fig. 20 shows a 1/4 section close to the collision region and the damaged 1/2 section. The strain in the tensile zone did not agree with the plane-section assumption. The strain in the 3/4 section, which was far from the collision section, presented a linear distribution along the beam depth, while the strain in the tensile zone was obviously large. The concrete tensile strain value for the midspan section of the damaged beam was approximately zero. The concrete exited from the operation, and the concrete strain in the compressive zone maintained a linear distribution.

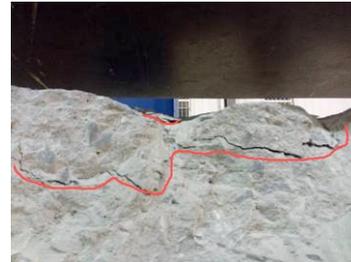
When 400 kN was loaded, the strain of rebar 1# at the beam bottom steeply increased, and the rebars successively yielded. The cracks in the damaged section continuously expanded and extended upward, and the cracks in other parts also expanded continuously. When the strain was 430 kN ,

the concrete in the compressive zone of the damaged section was crushed (Fig. 21). The crack on the damaged section of the main beam developed into the position running through the neutral axis and one yielded rebar going through the tensile failure (Fig. 22). The cracks in the test beam are shown in Fig. 23, which indicates that the test beam reached the limit state of the bearing capacity, and the failure mode of the damaged beam was a typical under-reinforced failure. The prior failure of the damaged section further indicated that the damaged section was a weak section of the component.

Fig. 21. Top Concrete is Crushed

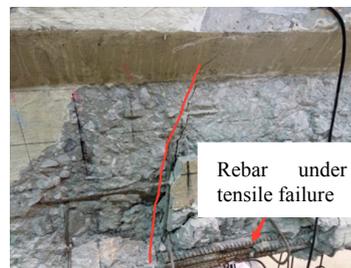
Fig. 22. Cracks on the Damaged Section Expanded

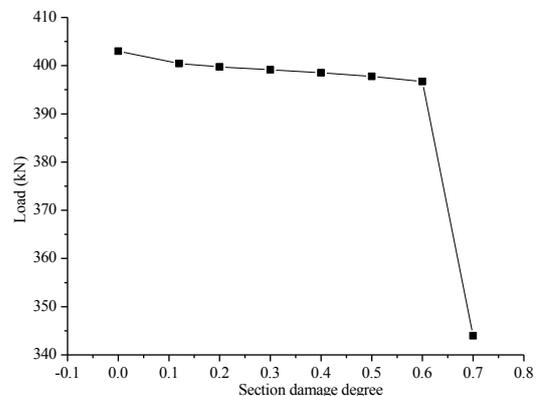
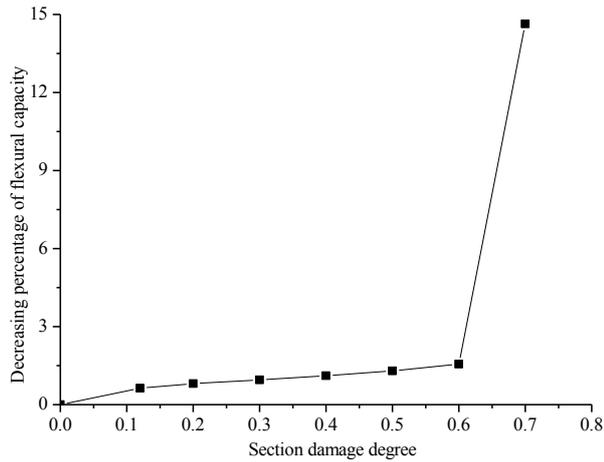
Fig. 24. Relation Curves between Flexural Capacity and Concrete Damage Degree in the Tensile Zone

The relation curves between the flexural capacity of the RC and the concrete damage in the sectional tensile zone (Fig. 24) indicated that the ultimate flexural capacity decreased slightly when the cross-sectional damage degree was smaller than 0.6. Therefore, the normal section calculation of the RC component did not consider the contribution of concrete to tensile resistance in the tensile zone. When the damage degree reached 0.7, the flexural capacity sharply decreased because cross-sectional damage entered the compressive zone. Therefore, the degree of decrease of the short-term flexural capacity brought by the concrete damage in the tensile zone could be 5% when the RC beam was damaged by collision, provided that the upper edge of the damaged position did not exceed the neutral axis.
