## New Low-interference Seismic Strengthening Method for Masonry Structures

The current seismic strengthening methods for masonry structures usually require the removal of wall decoration and superficial mortar, and the wet work during indoor construction takes a long time, which seriously interferes with the normal life of residents. To realize the low-interference construction in the seismic strengthening process of masonry residences, a new seismic strengthening method was proposed in this study. The reinforcement was performed by adding the ring beam and constructional column into the exterior wall and the ring beam into the interior transverse wall. Based on field detection and appraisal, the following three seismic strengthening methods were compared: steel mesh mortar splint, sticking carbon fiber reinforced plastic composite materials, and the addition of constructional column and ring beam. The seismic behavior of the building was investigated by using the JGJD module of PKPM structure design software. The following parameters were calculated: average seismic capacity index (ASCI), compound seismic capacity index (CSCI) of the floor, the resistance to load effect ratio (R

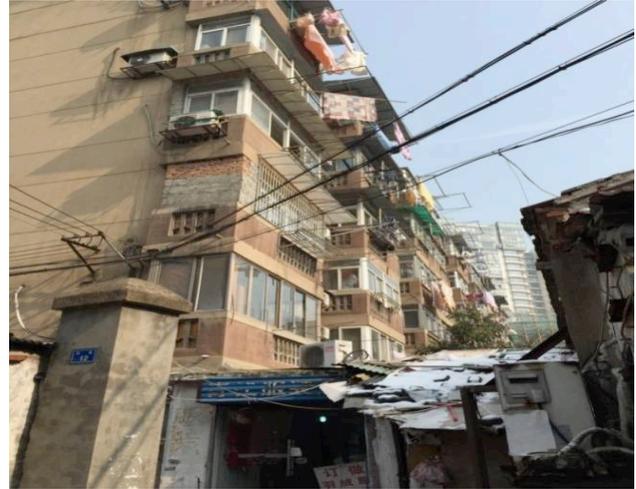
Fig. 1. Physical view of the building

Zhenxiang Block 12 Building in Qinhuai District of Nanjing was constructed in 1978, and it was a six-story masonry residential building. The building plane was a rectangle of 55 m × 9.1 m (length × width). The building area was 2,670 m<sup>2</sup>. The building adopted a load-bearing structure of 240 mm brick walls. The floor slabs were the precast concrete cellular slabs. The cast-in-place slabs were used in kitchens and bathrooms. The stairs were comprised of steel reinforced concrete. In addition to the ground and top ring beams, the ring beam was present in Floors 1, 3, and 5 but not in Floors 2 and 4. No constructional column was found. The ordinary cement ground was constructed. The building appearance is shown in Fig. 1.

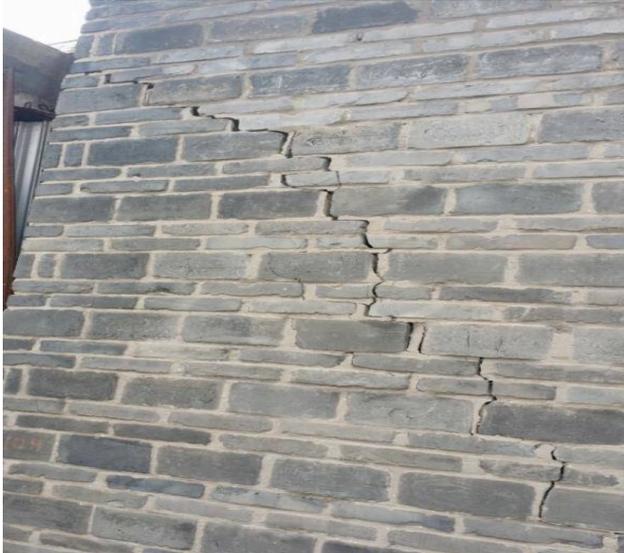
Fig. 2. Oblique cracks of walls

(4) The walls and floor slabs had obvious cracks, and the maximum crack was up to 1.2 mm wide. The cracks are shown in Fig. 2–4.

Thirteen typical cracks were selected, and the width was precisely measured as 0.3–1.2 mm with a crack width meter. The cracks with the biggest width were separately located in the walls beneath the windows of the southwest bedroom of Room 503 in Unit 1 and the southeast bedroom of Room 408 in Unit 3.

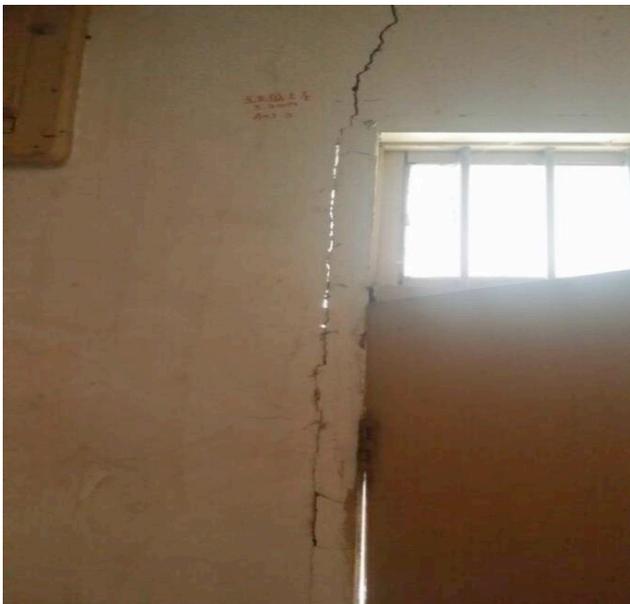
Fig.3. Wall crack lateral to the doorframe

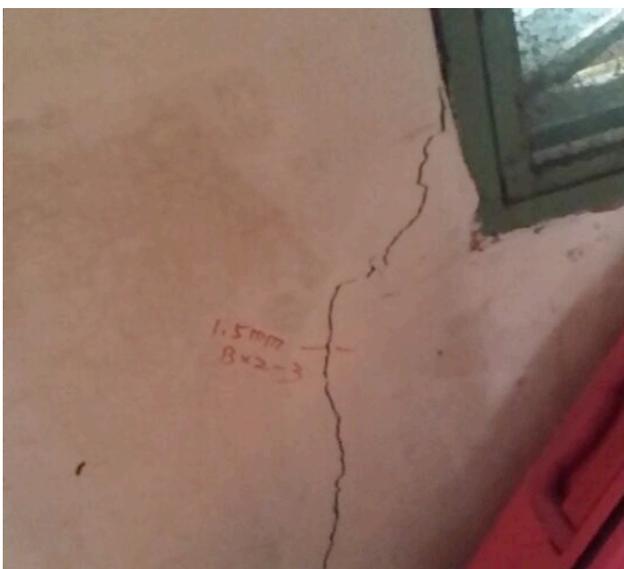
Fig. 4. Wall crack beneath the window
