## Meso-Analysis of Crack Propagation in Loess under Lateral Unloading Action

Crack development in loess is an important factor for loess collapse, while cut slope unloading accelerates crack development in loess. However, the macroscopic loess reaction characteristics and meso-structural changes under unloading action have not been systematically and comprehensively explained yet. A lateral unloading test of undistributed loess samples was conducted through GDS unsaturated soil triaxial instrument to simulate the load-carrying path of loess during the loess slope excavation process, followed by analysis via CT scanning image analysis technique. This test aims to explore crack propagation laws in loess and the propagation mechanism under lateral unloading action. Test results indicate that, 1) Numerous cracks appear inside the loess samples after complete failure due to the weakening and strengthening of loess and frictional strength, respectively; 2) Elastic deformation decreases while elastoplastic and plastic deformations increase with the unloading rate. The crack propagation in loess is evident and the CT number and its variance are large when the unloading capacity and rate

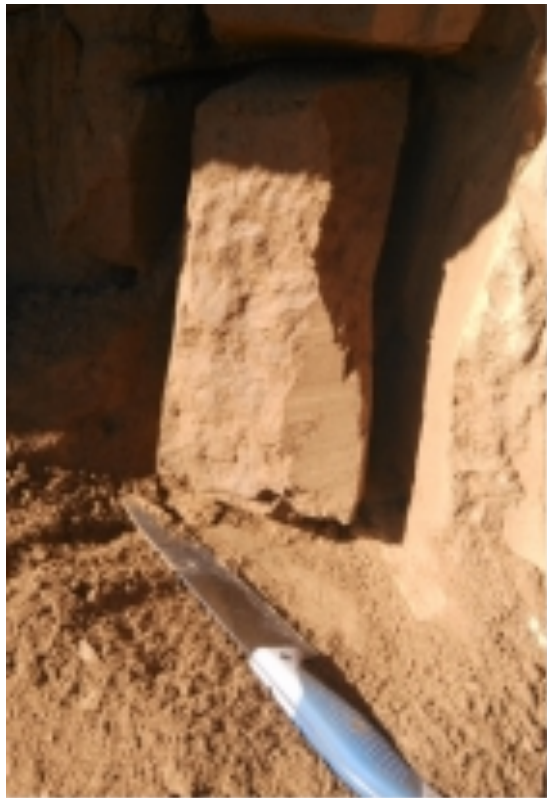
**Fig. 1.** Unsaturated loess samples obtained from the field

$Q_3$  unsaturated loess samples were taken from typical loess collapse points on tableland in Luochuan developed with

unload-induced cracks. These samples were s yellowish-brown without stratification but with vertical joints, the soil texture was uniform, wormholes were observed, and macropores were found locally. White calcareous concretion, which was slightly wet and presented a hard plastic state, was also observed. The physical property indexes of the loess samples are listed in Table 1.

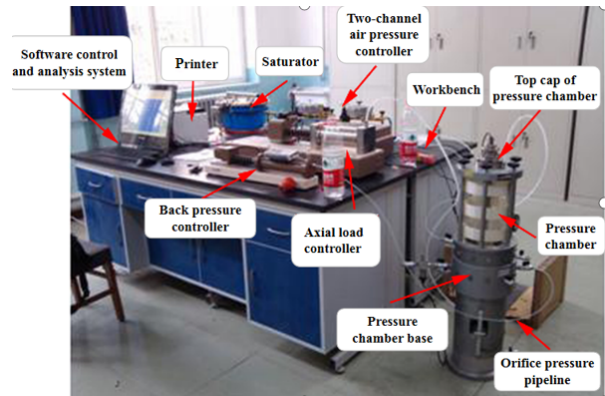
**Fig. 2.** Instrument and equipment. (a) GDS unsaturated soil triaxial instrument. (b) CT scanner.

The equipment used in the unloading test was GDS unsaturated soil triaxial testing system (Fig. 2 (a)) from Xi'an University of Science and Technology. Researched and developed by Geotechnical Digital System Instruments Ltd (UK), this instrument can complete saturated and unsaturated soil static triaxial tests under multiple stress paths.

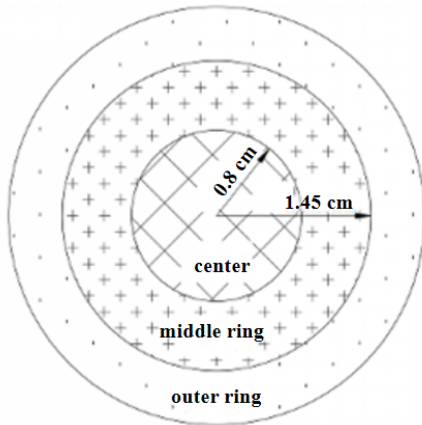
Fig. 3. Zoning graph of scanning section

Each scanned section was zoned (Fig. 3): from section center to edge were center, middle ring, and outer ring successively and two synthetic zones, namely large and whole zones; large zone was the sum of center and middle rings, and whole zone was the sum of center, middle ring, and outer ring. The loess sample was  $\phi 39.1 \text{ mm} \times 80 \text{ mm}$  in size in the initial scanning phase, and the corresponding area of the whole zone was 12.00 cm<sup>2</sup>. The diameter and area of

center were 1.60 cm and 1.96 cm<sup>2</sup>, respectively; those of large zone were 2.90 cm and 6.50 cm<sup>2</sup> respectively; and those of the middle ring were 4.54 cm and 5.50 cm<sup>2</sup>, respectively.

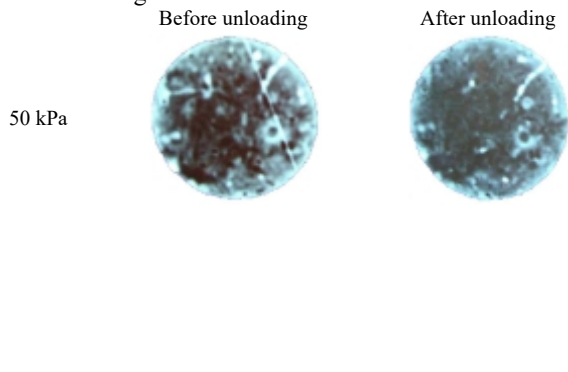
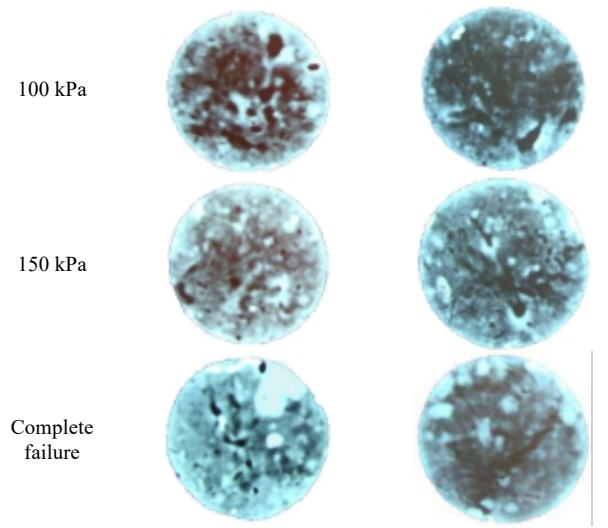
**Fig. 5.** CT scanning results of loess samples before and after unloading under different unloading capacities. (a) CT scanning images. (b) Change in CT number. (c) Variance change in CT number.

Through the CT scanning test, CT scanning results of loess samples ( $\omega = 13\%$ ,  $\Delta q = 0.08$  kPa/min) before and after unloading under different unloading capacities were acquired (Fig. 5). According to CT scanning images before unloading, many pores, cracks, and large loess particle aggregates existed in the samples. These media were under disordered distribution with non-uniform sizes, the connection between particles and that between particle and cement were weak, and many microcracks were distributed at particle boundary. These findings indicate that important initial meso-structures were formed at the particle boundary of the loess samples, generating initial damages with remarkably strong non-uniformity. For example, CT numbers of four samples in initial scanning were 1084.98, 1083.53, 1095.84, and 1084.62. Thus, the samples were slightly similar in overall density. However, CT number varied from zone to zone, where CT number of central zone was the minimum, followed by that of middle and outer rings. This finding indicates that sample density was gradually reduced from inside to outside possibly because of disturbance caused by sample preparation to loess samples. The variance of CT number could also be different in various zones in the same section of each loess sample, where the variance in the central zone was minimum, followed by that in large and whole zones successively. Thus, internal structures of loess samples, especially pore size and position, were different under the initial state. Under small unloading capacity (50 and 100 kPa), the meso-structural changes in loess samples were not observed before and after the test, and CT numbers in all zones were slightly enlarged. However, the increment amplitudes of CT number in the zones were different, where the increasing amplitude

in the center was the minimum, followed by that in the middle and outer rings. The unloading capacity reached 150 kPa, microcracks appeared in loess samples, and their CT numbers were reduced in comparison with those before unloading. The unloading capacity was continuously enlarged until complete failure, a thorough crack approximately 46 mm in length and 2.5 mm in width appeared, CT numbers in the outer and middle rings were reduced, and the reduction amplitudes of CT numbers in different zones were varied. The reduction amplitudes in the outer and middle rings were respectively large and small. The variance of CT number declined as the unloading capacity was reduced; that is, original holes and cracks were compressed tightly under pressure action. The variance of CT number was gradually enlarged with the unloading capacity.

Overall, cracks would appear inside loess only when a certain unloading capacity was reached. Each loess sample remained in the elastic deformation phase under small unloading capacity, internal loess structure was undamaged, and consolidated compression generated to the loess sample under the action of consolidated confining pressure was the primary cause for meso-structural change. Moreover, as confining pressure was directly applied to the edge of loess samples, the stress in the central zone was gradually increased. This increase led to the maximum and minimum compaction degrees in the outer ring and the center, respectively. In addition, given that confining pressure and moisture content were small, internal structural change in loess samples was small, and CT number and its variable presented minor changes. The stress-strain curves (Fig. 4) show that the loess sample was turned from elastic into elastoplastic deformation as the unloading proceeded. Given that the unloading capacity was small while confining pressure was relatively high, plastic deformation inside the loess was mainly due to local stress concentration, and the arrangement order of some particles was adjusted where the loess particles were weakly bonded. When the unloading capacity reached a certain value, the stress state requirement could not be reached by adjusting the order of loess particles, a large quantity of energy aggregated inside the loess would be released by tearing the loess. These conditions lead to crack propagation and penetration. During the unloading process, internal lateral stress was gradually reduced from the edge to the center of the loess, loess particles or aggregates underwent axial movement from two ends to the middle under the action of axial compression, and radial movement was observed from the center to the edge. The loess in the outer ring was under the action of tensile stress, while the central loess remained in the compaction state under the action of axial stress. Therefore, the reduced amplitude of the CT number in the outer ring was larger than that in the middle ring, while the CT number in the central zone was enlarged.

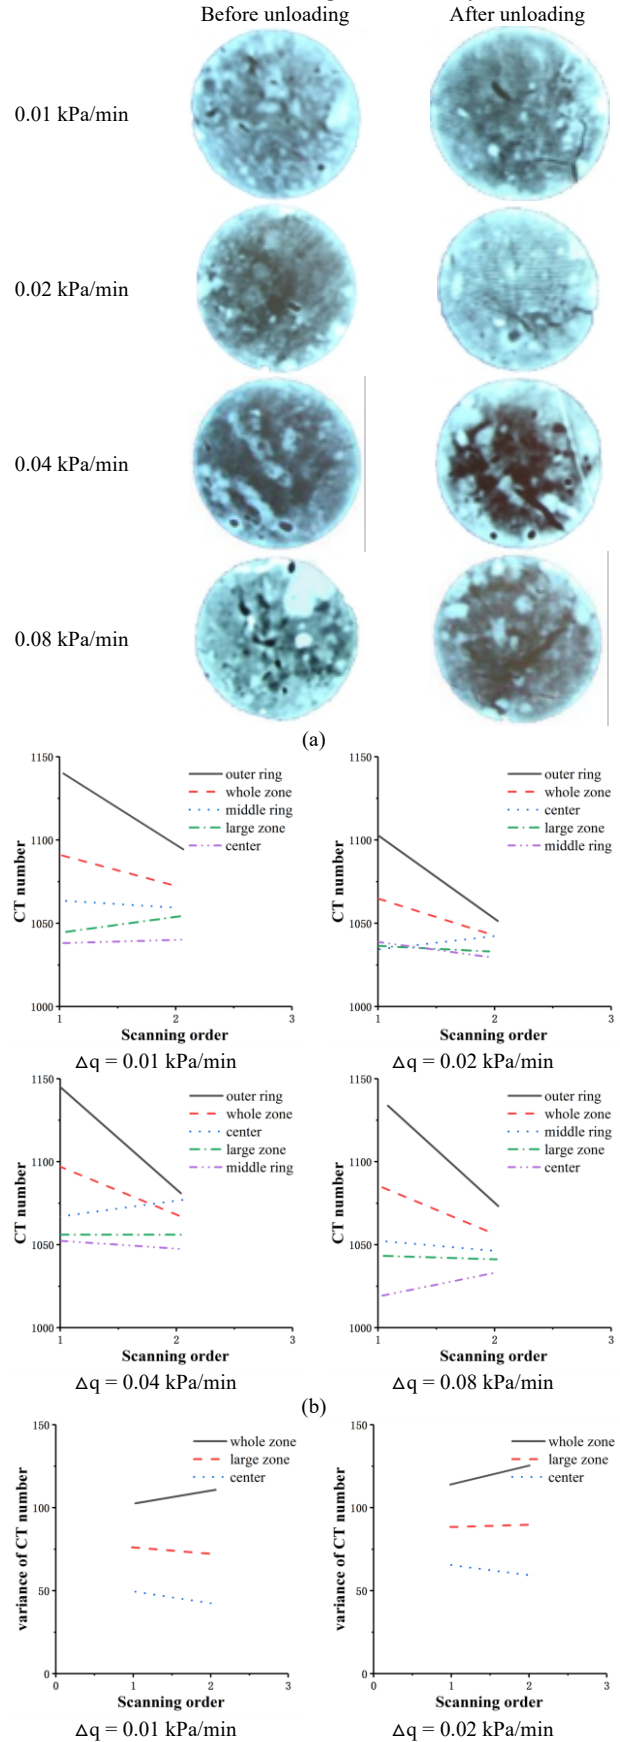
Fig. 6. CT scanning results of loess samples before and after unloading under different unloading rates. (a) CT scanning images. (b) Change in CT number. (c) Variance change in CT number.

Fig. 6 displays CT scanning results of loess samples ( $\omega = 13\%$ , complete failure) before and after unloading under different unloading rates. CT scanning images in Fig. 6 (a) reveal that the crack propagation in each sample became evident as the unloading rate increased. Under low unloading rate, microcracks, which were narrow and short, were well developed and mainly distributed at the edge. The crack width was large nearby the edge; the crack width was small when it was close to the center. Moreover, cracks presented staggered distribution with dendritic shape, and the crack propagation evolved from the edge toward the center. Fig. 6 (b) shows that the CT numbers in the middle and outer rings in each loess sample were decreased after the unloading test, the CT number in the center was enlarged, and the variable quantity of CT numbers could be different under various unloading rates; that is, the variable quantity increased with unloading rate. The variable quantity of the CT number was different in various zones, wherein the variable quantity in the center was the minimum, followed by those in the middle and outer rings. Fig. 6 (c) shows that the variable quantity of CT number variance increased with unloading rate; otherwise, the variable quantity would be reduced.

Overall, a high unloading rate results in remarkable crack propagation. The impact of unloading rates on crack propagation loess samples was related to particle movement in the shear process. That is, loess particles underwent relative movement under the action of unloading stress and presented radial and axial movements from the center to the edge and from two ends to the center, respectively. Under low unloading rate, loess particles had sufficient time to move, and the density difference between various zones inside the loess sample was small. Thus, the change in CT number was relatively small. The concentrated stress generated at the tip under crack propagation could be rapidly weakened through relative movement between particles. When defects, such as pores and holes, were encountered in crack propagation, concentrated stress at the tip was further weakened. Thus crack width was generally small. As the unloading proceeded, cracks started propagation in new directions, causing a curved crack shape. The energy aggregated at the crack tip was transferred to loess particles to overcome resistance and generate movement. Consequently, the deformation of loess samples, which was manifested by plastic flow failure from the macroscopic level, was large. Under high unloading rates, the concentrated stress at the tip of internal cracks could not be absorbed by loess particles within a short time, and the energy was mainly released through crack propagation. Thus, crack propagation was aggravated, and crack width and length were enlarged. As loess particles had insufficient time to move under high unloading rate, the amount of movement was small, the order could not be fully adjusted, the variable quantity of crack propagation direction was relatively small, and crack shape was smooth. Furthermore, during the unloading process, the peripheral stress was first released, and loess particles rapidly moved toward the edge of the loess sample. Similarly, loess particles in the center also had insufficient time to move. Consequently, the variable

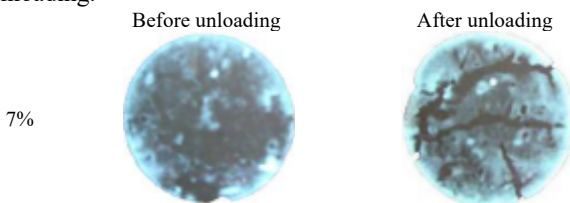
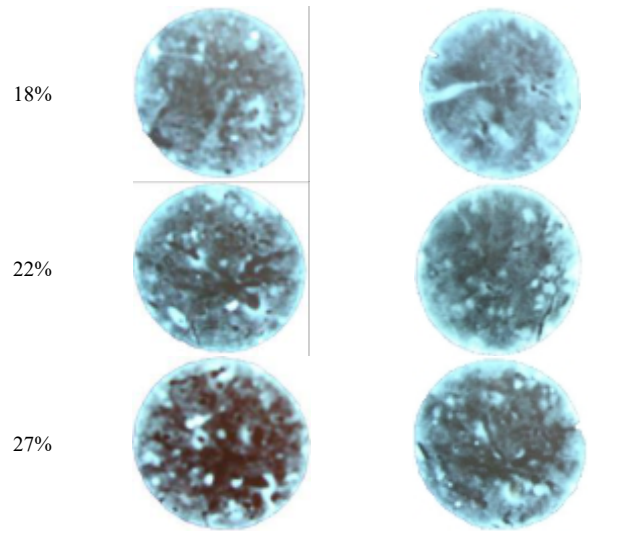
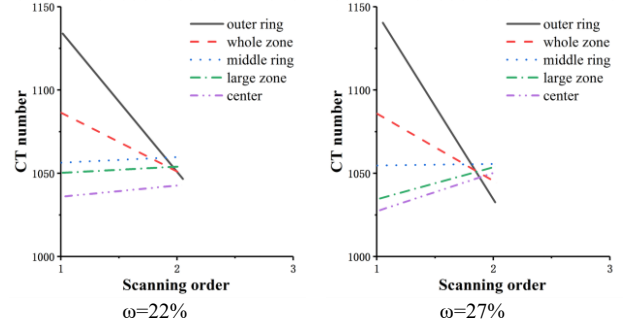
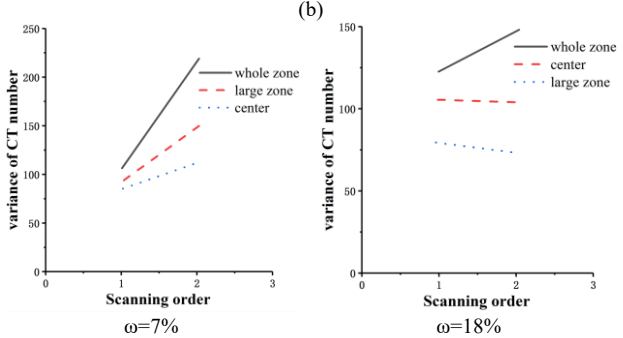
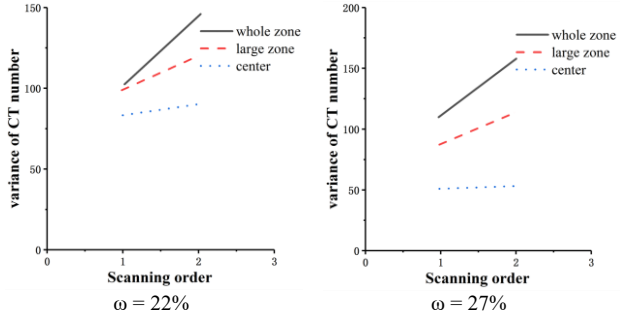
Fig. 7. CT scanning results of loess samples with different moisture contents before and after unloading. (a) CT scanning images. (b) Change of CT number. (c) Variance change in CT number.

The CT scanning results of loess samples with different moisture contents before and after unloading ( $\sigma_{ic} = 200$  kPa,  $\Delta q = 0.08$  kPa/min, complete failure) are displayed in Fig. 7. Fig. 7 (a) shows the presence of numerous cracks inside the loess sample with large crack width under low moisture content ( $\omega = 7\%$ ). These cracks were mutually staggered. As the moisture content was increased ( $\omega = 18\%$ ), shear failure zone, sectional cracks, and a few holes appeared inside the loess sample, the internal shear zone was observed, and the loess inside the shear zone loosened. When moisture content  $w \geq 22\%$ , microcracks were considerably developed inside the loess sample. However, coarse cracks could be hardly observed because cracks were mainly distributed in the middle and outer rings with small length and width and are crossed. Under different moisture contents, the CT numbers in the outer ring, middle ring, and other samples were respectively reduced after unloading, enlarged, and decreased. The CT number in the central position and its variance were enlarged. Moreover, the variable quantity of the CT number was increased but that of the CT number variance was reduced with the increase in moisture content.

The analysis results show the following: loess strength was high under low moisture content; the deformation was small during the unloading process; the energy aggregated in loess was rapidly released; crack propagation was evident; wide and large cracks were quite developed and mostly presented brittle failure; most loess skeleton structures were undamaged or slightly damaged, except for those nearby cracks; density change in all zones was minor, thus indicating the relatively small degree of the CT number variation. Under high moisture content, water weakened the bonding strength between particles and the cementation effect between loess particles. During the unloading process, most of the original structures inside loess were slightly or completely damaged, loess particles could move freely, large deformation was observed, and plastic flow failure usually occurred. Consequently, many microcracks were found, and CT number demonstrated numerous changes before and after unloading.
