Damage Evolution and Mechanical Characteristics of Porous Rock Under Uniaxial Cyclic Impact Loads

Keywords: cyclic impact, SHPB, granite, constant stress

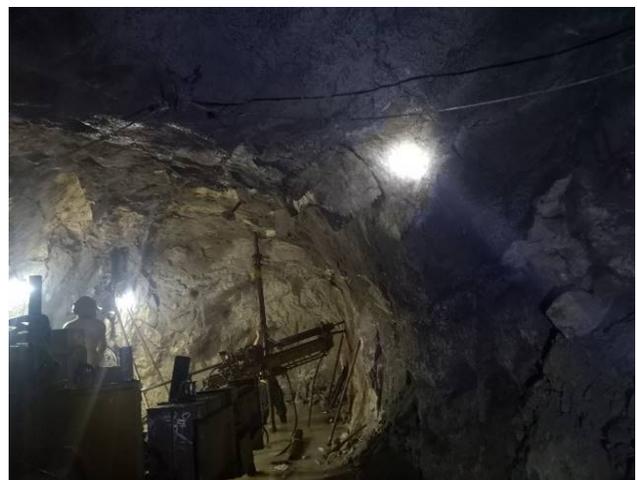
Fig. 1. Site drilling sampling

The granite sample used in this test was taken from the deep -960m of Sanshandao Gold Mine in Laizhou City, Shandong Province. After the uniaxial compression test, the average uniaxial compressive strength of the sample is 88.3MPa, the Poisson's ratio is 0.202, and the average elastic modulus is 37.656GPa. The granite sample was cut after core drilling with water drill to make a disc-shaped specimen of $\Phi 50$ mm \times 25 mm, as shown in Fig. 1 and Fig. 2. In order to avoid stress concentration caused by biased pressure during the processing of the rock sample, the unevenness of the specimen is controlled within 0.02mm. The void ratio of the test piece is relatively large, and the uniformly distributed, irregular original damage cavity can be seen on the surface of the test piece, and the maximum diameter is about 1mm. Based on this, it is inferred that there are similar original damage structures evenly distributed inside the specimen.

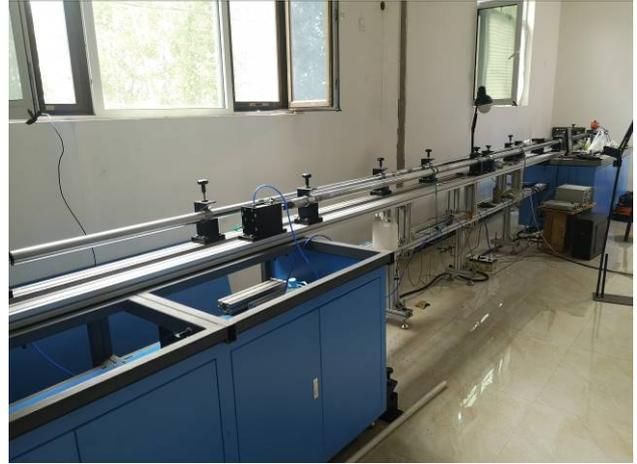
Fig. 3. Large-diameter split Hopkinson pressure bar system

The impact test uses an improved large-diameter (50mm diameter) SHPB device. During the test, the bullet hits the incident rod to form a compressed pulse. When this pulse propagates to the interface between the steel rod and the rock specimen, part of the pulse is reflected back to the incident rod, and the other part continues to propagate in the original direction, forming a transmission pulse in the transmission rod. The whole process is measured by the strain gauges attached to the incident rod and transmission rod. According to the one-dimensional stress wave theory, the "three-wave method" formula suitable for brittle materials is selected to process the signal, and the stress, strain and strain rate calculation formulas can be obtained:

kept constant, and the specimen is subjected to cyclic impact until the specimen ruptures. Fig. 3 shows the split Hopkinson pressure bar device.

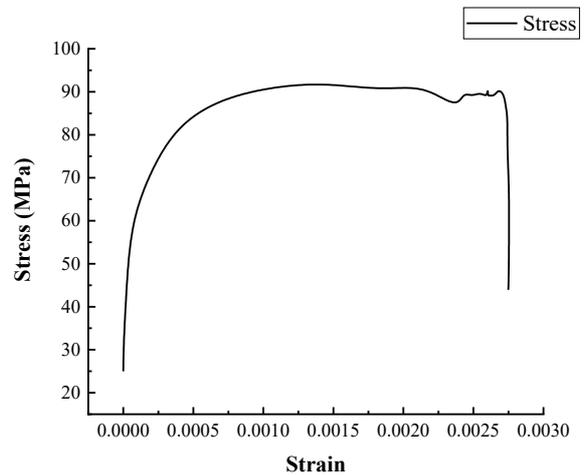
Fig. 4. Typical stress-strain curve during cyclic impact

Fig. 4 shows the typical half stress-strain curve (the third impact) of the A1 specimen during the cyclic impact under the accelerated air pressure of 0.09MPa. During the impact process, the change trend of the stress-strain curve is similar and can be roughly divided into three stages.

In the first stage, at the beginning of the impact load, there is an approximately straight section, which is relatively short and is an elastic stage. In the second stage, the curve enters the nonlinear deformation stage and the slope of the curve gradually decreases. In the third stage, when the stress peak is reached, the stress did not drop immediately, but remained constant, and the strain continued to increase, forming an obvious constant stress stage. The stress dropped rapidly in the subsequent rebound stage, and the data became invalid.

It is analyzed that due to the large void ratio inside the specimen, the normal tensile stress in the specimen reaches the threshold of crack propagation during the constant stress stage, causing the crack to break and the direction of the crack is axial. In the process of crack opening, the strain increases continuously and the axial stress remains unchanged. Stress concentration areas are formed at both ends of the crack, which causes the crack to continue to expand in the axial direction.

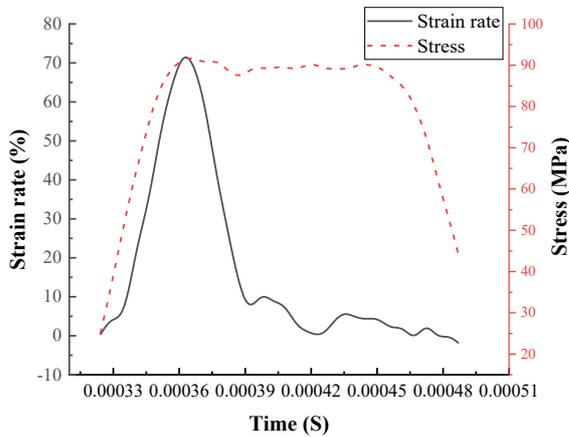
Fig. 5. Strain rate-stress-time diagram

The change rule of strain rate with time is shown in Fig. 5. As the stress in the elastic stage increases, the strain rate increases rapidly, and both peaks appear at the same time, which is also in line with the stress-strain rule in the elastic stage. Subsequently, the stress remains stable and the strain rate drops rapidly. During this process, the cracks rapidly expand and the incident energy is converted into the surface energy of the new cracks. Then the number of activated cracks decreases, and the constant stress continues to remain unchanged, showing a certain hysteresis.

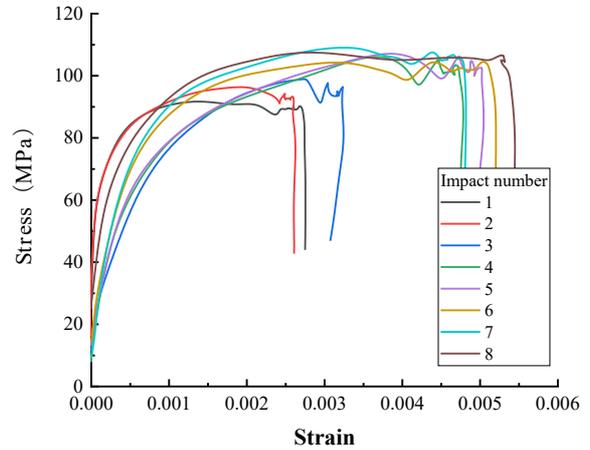
Fig. 6. Cyclic impact stress-strain curve under 0.09MPa impact air pressure

The stress-strain situation of the A1 specimen under the accelerated air pressure of 0.09MPa is shown in Fig. 6. As the number of impacts increases, the plasticity of the granite specimens increases during the impact.

The curve trend of the first two impact processes is similar, the maximum stress value is small, about 90MPa. The maximum strain value is obviously smaller, about 0.0027, and the stress constant stage is obvious. From the 3rd to the 5th impact, the curve showed a linear-nonlinear-linear change trend, the maximum stress and maximum strain increased, and there was no obvious constant stress stage. During the 6th to 8th impact, the constant stress stage reappeared, and the maximum stress and maximum strain were similar to the 3-5th.

The first is the compacting stage of the original pores: during the first two impacts, the compacting effect of the original pores is obvious. When the stress reaches its peak, the void collapse causes a short unloading process, causing the stress to not increase further. The crack has not been fully developed, the damage degree of the specimen is small, and the maximum strain is small.

Damage nucleus formation stage: During the 3-5 impacts, after the large-size original cracks are compacted, the strength of the specimen increases slightly, and the original damage nuclei begins to form and increase rapidly, but the crack size is small, resulting in constant stress during the impact. Elevated, there is no obvious constant stress stage.

Finally, the crack propagation and crack penetration stage: After the number of activated cracks quickly reaches the peak, the cracks rapidly expand and penetrate in the axial direction until the specimen is destroyed. The unloading effect caused by the opening of the crack makes the constant stress stage reappear.

Fig. 6-Fig. 9 shows the stress-strain curve of the sample under different impact loads, among which Figure 6-Figure 8 is the cyclic impact load test, and Figure 9 is the single impact failure test. Define the maximum stress of the loading section as the peak stress, and the strain value obtained before the data failure is the maximum strain.

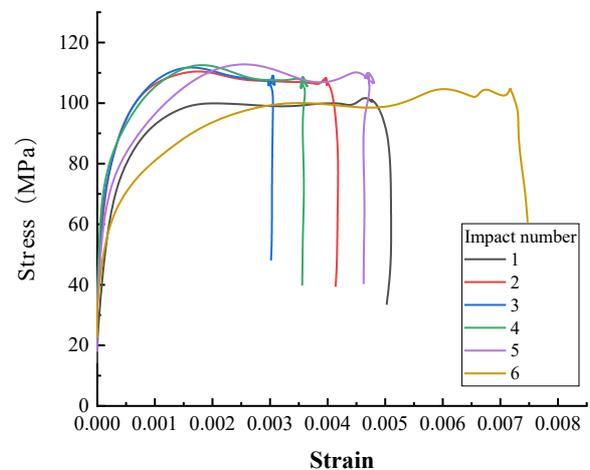
Fig. 7. Cyclic impact stress-strain curve under 0.12MPa impact air pressure

Fig.7 shows the stress-strain situation of the B1 specimen under the acceleration condition of 0.12MPa. The trend dispersion of the curve is small. The strain of the first

impact and the last impact is larger, the maximum stress value is smaller, and other impact processes The curve overlap is higher, and the strain value increases steadily. It shows that the compaction effect is obvious during the initial impact, the stress value is smaller, and the strain value is larger. Due to the relatively large load, in the subsequent impact process, the nucleation and crack expansion in the specimen proceeded simultaneously, and there was no obvious differentiation. During the whole process, the constant stress stage of the curve is obvious. In the last impact, the crack penetrated rapidly, the maximum stress decreased, and the maximum strain increased significantly.

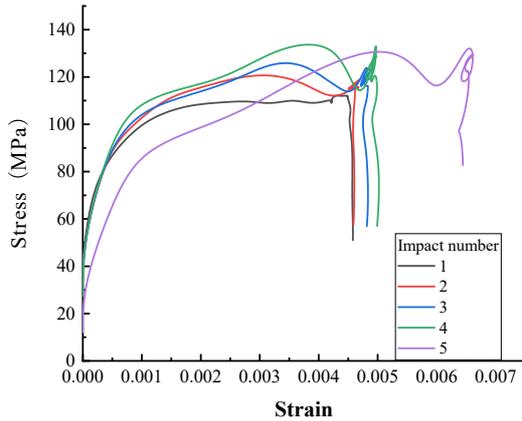
Fig. 8. Cyclic impact stress-strain curve under 0.16MPa impact air pressure

Fig. 8 shows the acceleration air pressure of 0.16MPa, which generates a relatively large dynamic load, which is about 90% of the maximum impact load. Under this condition, the C1 specimen has an obvious constant stress stage during the first impact. From the second to the fourth impact, when the stress is around 110 MPa, the slope of the curve tends to decrease rapidly, followed by a secondary increase in stress. Due to the accumulation of damage in the specimen, the stress-strain curve of the fifth impact showed a larger peak strain, and the elastic modulus was also significantly reduced, but the maximum stress change was not obvious. The analysis believes that under a large impact load, the crack propagation and opening process cannot fully release the impact energy, causing the stress to rise again after a short unloading action.

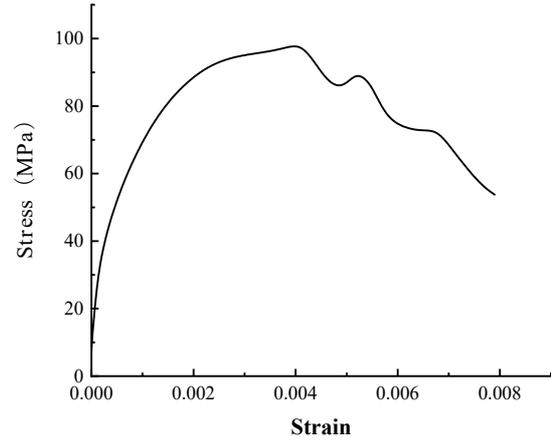
Fig. 9. Stress-strain curve of single impact failure under 0.20MPa impact air pressure

A set of single impact failure tests are added for comparison and the typical stress-strain curve is shown in Fig. 9. Under the working condition of the impact air pressure of 0.2MPa, the maximum stress of the single impact failure of the D1 specimen is 97.69612MPa, which is close to the maximum stress of the first impact during the cyclic impact. After reaching the peak of the stress, there is no obvious constant stress stage, indicating that under the action of larger impact load, the internal micro-cracks of the test piece have not been fully developed, but quickly penetrated along the weak surface, causing the damage of the test piece.

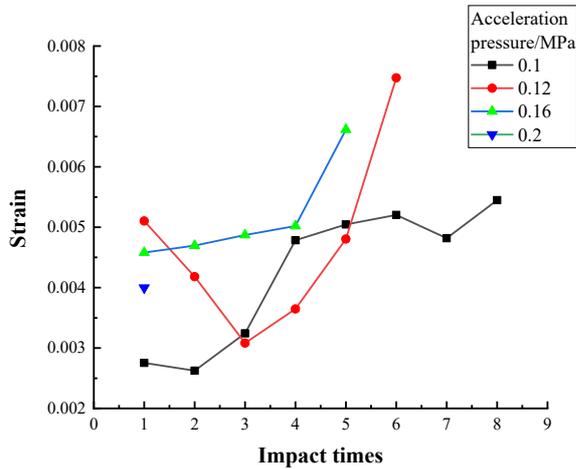
Fig. 10. Peak strain change during cyclic impact

The change rule of strain with the number of impacts during impact is shown in Figure 10. The peak strains of A1 and C1 specimens generally show an increasing trend with the increase of the number of impacts. Among them, the rising trend of the peak strain of the A1 specimen is unstable. The reason is that under the action of low-strength impact, the compaction effect of the crack and the expansion effect of the crack appear sequentially during the impact process. The peak strain during the first three impacts is low, which is manifested as compaction, but too small impact load is not enough to cause a large amount of collapse of the original void. The upward trend of the 5th-8th impact is slower, mainly due to the expansion of cracks. The C1 specimen received a relatively large impact load, which was about 90% of the impact load. The main reason for the increase in peak strain was the propagation of cracks. The slope of the steady rise of the peak strain is very similar to that of the A1 specimen in 5-8 shocks, which also proves this. The peak strain change trend of the B1 specimen shows an obvious trend of first decreasing and then increasing. Because compaction and crack propagation occur simultaneously during the punching process, and the initial compaction is obvious.

When the D1 specimen is subjected to a large impact load, its maximum strain is 0.00399, which is lower than the first impact strain under 0.12MPa and 0.16MPa impact air pressure conditions. It also reflects that the cracks inside the specimen have not been fully developed when a single impact is damaged under a high load.
