## Evaluation Classification of Weathering Degree of Stone Cultural Relics by Infrared Thermal Imaging

It is very important to reveal the weathering characteristics of stone cultural relics to protect their integrity for a long time. Infrared thermal imaging was employed in this study to analyze the degree of weathering and classification of stone cultural relics for the protection of the cultural relics. To explore the feasibility of evaluating the overall weathering degree of rock surface, the weathering degree of the rock surface was first determined by using various conventional testing methods. Then, the weathering degree of rock surface was quantified by applying infrared thermal imaging. Finally, the weathering degree of the rock surface was analyzed by comparing it with conventional testing results. Results show that, the infrared thermal imaging can distinguish general disease types and degrees of development based on abnormal surface temperature. When the surface weathering of stone cultural relics is more serious, the temperature change at a certain time is greater after water spraying and cooling. The conclusions obtained in this study can provide a reference for evalu

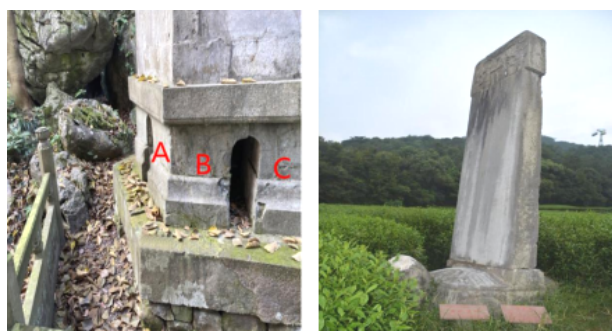
Fig. 1. Ligong Pagoda and Huang Ji Tombstone.

The Ligong Pagoda in China was built in AD 975, rebuilt in June AD 1587 due to the destruction of floods, and in AD 1590 when Monk Rutong presided over the reconstruction (Fig. 1a). The Ligong Pagoda is located in Lingyin Feilai Peak's Longhong Cave in China. The whole structure is of stone masonry, with six sides and seven stories. It is about 9 m high, and strongly depicts the style of the Ming dynasty Hangzhou. It is the only surviving Ming dynasty pagoda. The overall surface of the Ligong Pagoda is seriously weathered, with water seepage, cracks, hollow drums, and other defects.

The Huang Ji Tombstone in China (Fig. 1b) dates back to the Qing Dynasty Kangxi period, standing for 26 years (1687). The monument body is preserved, but the turtle-shaped pedestal is broken (turtle head). The total height is about 5.2 m, while the width is 1.2 m. The monument is huge, with Manchu and Chinese characters engraved on it. This tombstone has a certain historical research value.

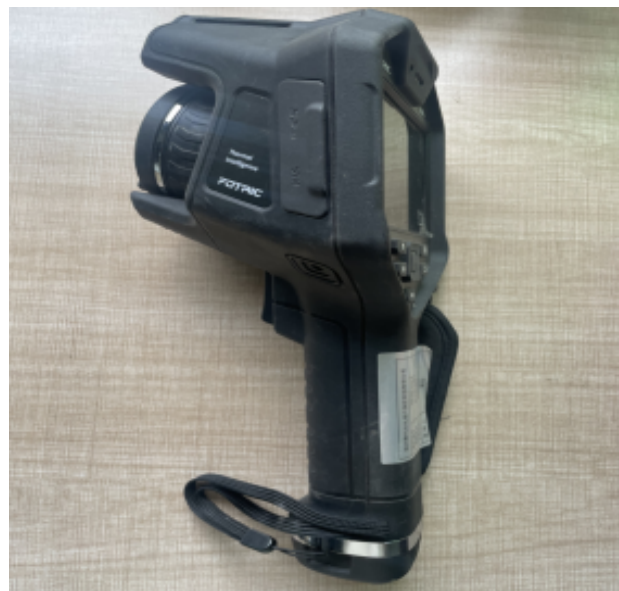
Fig. 2 FOTRIC 326Q handheld thermal imaging camera.

A FOTRIC 326Q handheld infrared camera was used, as shown in Fig. 2. It has a minimum imaging distance of 0.1 m, a temperature measurement range from -20 °C to 650 °C, a high degree of accuracy, and a simple operation that is easy to execute [32, 33].

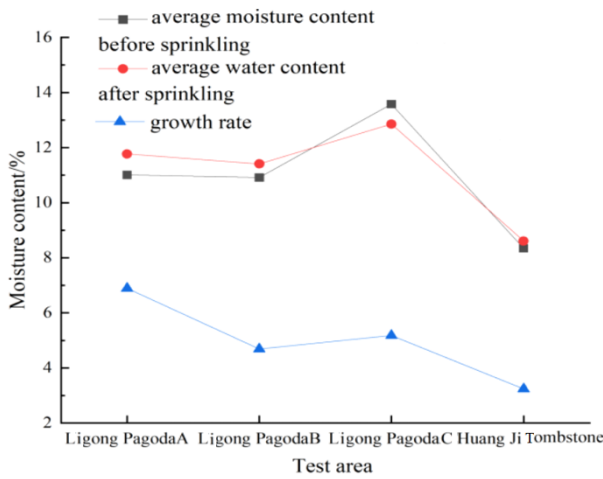
Fig. 3. Moisture content test data

The water content test data for the three areas of the Ligong Pagoda (A, B, and C) and the Huang Ji Tombstone are shown in Fig. 3. The hardness test data are presented in Fig. 4.

As shown in Figs. 4 and 5, Ligong Pagoda A has high water content, and the growth rate before and after sprinkling is considerably higher than those of the other areas, indicating that the internal porosity of the rock is large, and the material is loose. The surface is darker, with a

large amount of calcium sulfate crusts. Ligong Pagoda B has high water content, but the growth rate before and after sprinkling is generally high. The internal material is moderately dense, with low surface hardness. The surface hardness is low, because the long-term high-water content causes rock softening. Weathering degree is medium. Ligong Pagoda C has the highest water content. However, water content exhibits a downward trend after sprinkling water. On the surface of the rock, internal porosity is low and material is dense. Water cannot easily enter the rock's interior. The hardness value is higher, and the weathering degree is low. The water content of the Huang Ji Tombstone is low, and the growth rate before and after sprinkling is low. The hardness value is the highest, indicating that the internal material of the rock is densest, and the degree of weathering is the lowest.

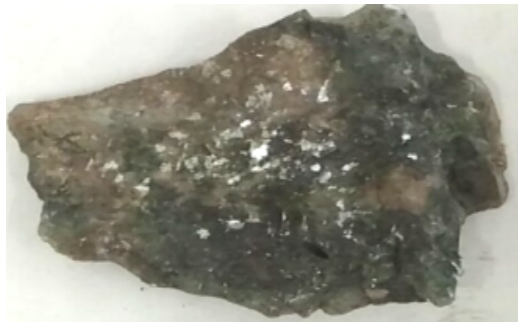
Fig. 5. Sample of Feilai Peak rocks

Note: Given the small surface of the three testing areas of the Ligong Pagoda, the longitudinal wave velocity is the average value of 10 groups of values, while that of the Huang Ji tombstone is the average value of 30 groups of values. The stone samples of the Ligong Pagoda and Huang Ji tombstone were detected as limestone, and the reference longitudinal wave velocity of fresh rock was about 4000–5000 m/s. The same material rocks (Fig. 5) were selected from Feilai Peak slope and brought back to the laboratory

after the surface weathering layer was cut. The average longitudinal wave velocity was about 4500 m/s after 30 ultrasonic measurements.

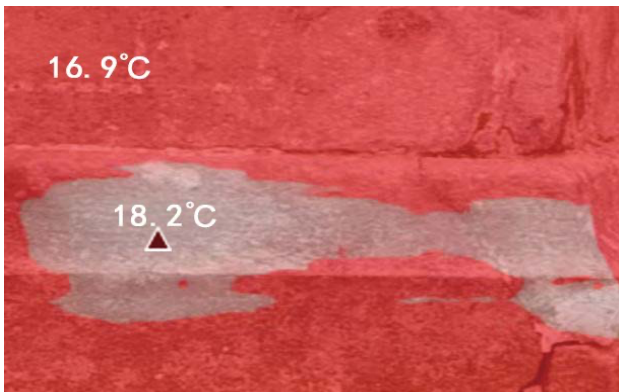
Fig. 7. Cavitation Zone A of Ligong Pagoda

Combined with Fig. 7, the light-colored area (temperature higher than the isotherm) accounted for nearly 40% of the total area. After the region coincided with the surface of cultural relics, it was presumed that there might be hollow drums on the surface of the relics, and the water sprinkler temperature in that region plummeted accordingly.

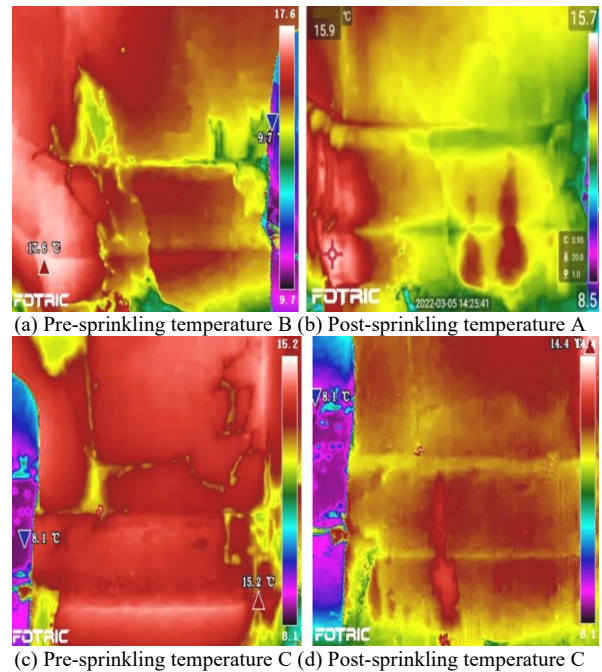
Fig. 8. Pre-sprinkling temperature in Zone B, Post-sprinkling temperature in Zone A, Pre-sprinkling temperature in Zone C and Post-sprinkling temperature in Zone C of Ligong Pagoda.

Figs. 8(a) to 8(c) show the Ligong Pagoda B and C areas before and after sprinkling. The infrared thermal image reveals the fissures in the Ligong Pagoda B and C areas. The more water, the more serious the leakage through the fissures. The temperature from the fissure to the surrounding area tends to increase. After sprinkling, the temperature drop near the fissure was faster.

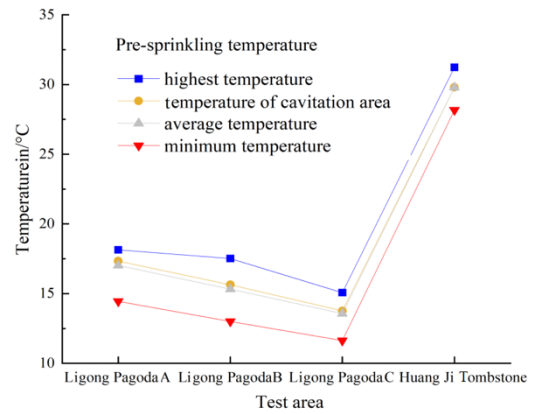
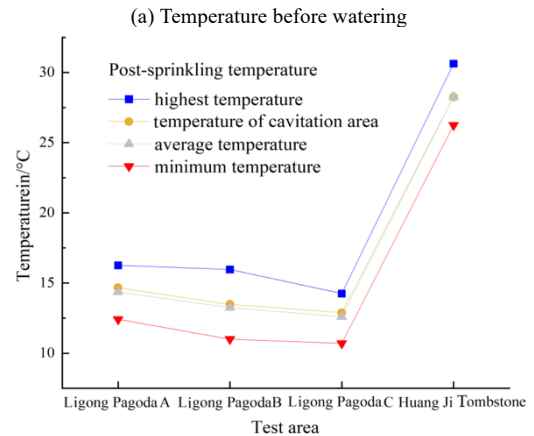
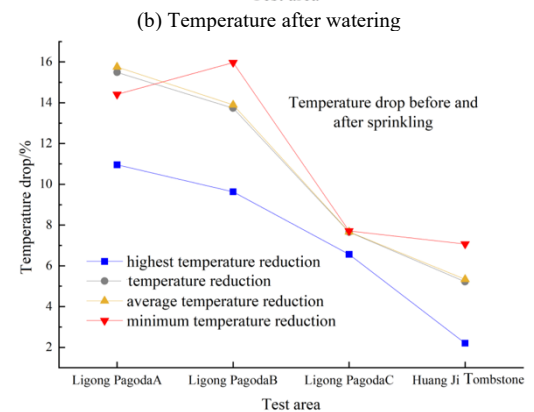
Fig. 12. Temperature before watering, after watering and Temperature drop before and after sprinkling.

Figs. 12(a) and 12(b) show the line graphs of different temperature values before and after watering in the four detection zones. Fig. 12(c) shows the temperature drop before and after watering in the four detection zones.

As shown in Table 4, the temperature change on the rock surface after sprinkling was approximately 0.30 °C higher than the average in area A, 0.20 °C higher in area B, and 0.25 °C higher in area C. The temperature change of the rock surface before and after sprinkling was also consistent. In addition, the trends of the highest, lowest, and average rock surface temperatures before and after irrigation and the magnitude of the temperature change were the same. The temperature in the hollow drum area is slightly higher than the average temperature and the drop in temperature after sprinkling is even greater. The combination of Figs. 9 to 11 indicates that the hollow drum area on the rock surface covers a significant range. However, except for a few points, the rest of the area is shallow superficial hollow drums that have not developed to depth. Upon analyzing the temperature drop data in Fig. 12(b), the difference between the lowest and highest temperature drops significantly suggests that the leakage damage on the rock surface is more severe than that associated with the hollow drum. Combined

with the infrared image, the leakage damage belongs to fissure leakage.
