## Assessment of Water Quality of Peddacheruvu, Sambaiah Cheruvu, Gaddapotharam and Rudraram Cheruvu of Medak District

Saritha Poodari, Shankaraiah Golla, Bhagawan. D and Vurimindi Himabindu\*

Center for Environment, Institute of Science and Technology, Jawaharlal Nehru Technological University, Hyderabad, India 500 085

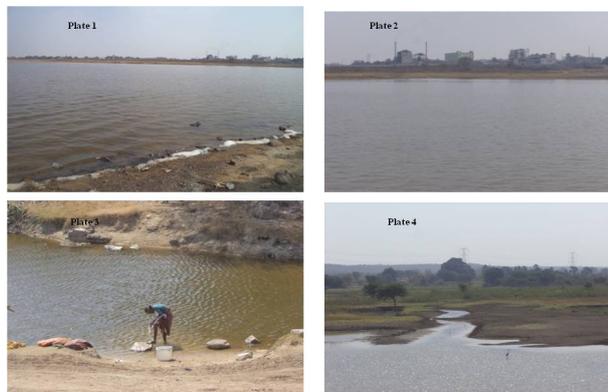
Fig. 1. Plate 1:Gaddapotharam Lake; Plate 2: Industries near Gaddapotharam Lake; Plate 3 Washing inlet to Peddacheruvu; Plate 4 Field inlet to Peddacheruvu

longitude in Medak district. The total area of the lake (Fig 1-Plate 1 & 2) is approximately 0.08 Km<sup>2</sup>. The total catchment area of the Gaddapotharam village is 0.093 Km<sup>2</sup> (approximately). The main catchment – industrial area (with a total industrial area of 2.5 Km<sup>2</sup> approx.) is located towards the southeast side of the lake. The lake is fed by 2-3 minor channels or streams. Maximum depth of the lake is about 10 ft.

**1.1.2 Pedda cheruvu:** It is located at a latitude of 17°44' and 78°23' longitude with a total area of 0.077 Km<sup>2</sup> and a depth of 3ft approximately (Fig 1-Plate 3 & 4). Towards north of the lake is the Gomaram village with a total catchment area of 0.3 Km<sup>2</sup> approx. while agricultural fields occupying approximately 0.28 Km<sup>2</sup> of area exists towards the south of the lake. Industries are located towards the northeast of the lake.

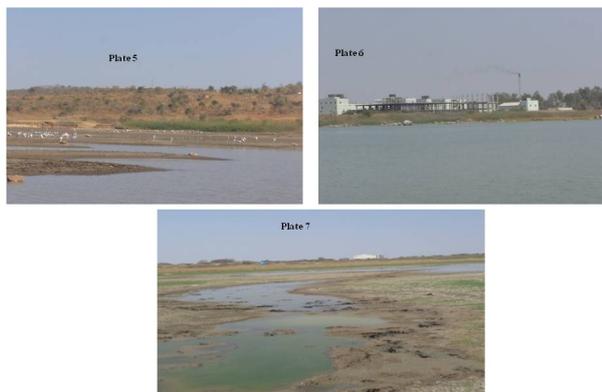
Fig. 2. Plate 5: Sambaiah Cheruvu with a number of birds; Plate 6:Industries at the North Eastern side of Rudraram cheruvu plate 7: Inlet at the South eastern side of Rudraram cheruvu with algae

**1.1.3 Sambaiah cheruvu:** It is located at a latitude of 17°43' and 78°23' longitude at an altitude of 2005 ft. The total area of the lake (Fig 2-Plate 5) approximates to almost 0.113 Km<sup>2</sup> and a depth of 3 ft. Towards northwest of the lake is the Nawabpet Village with a catchment area of approx. 0.163 Km<sup>2</sup>. Industries are located towards south of the lake at an altitude of 2125 ft.

**1.1.4 Rudraram cheruvu:** It is located at a latitude of 17°33' and 78°10' longitude. The total area of the lake is approximately 0.24 Km<sup>2</sup>. The depth of the lake (Fig 2-Plate 6 & 7) is about 5 ft approximately. Towards northwest of the
